Performance Comparison of a Low-E Retrofit Window at the Kevon Office Building

Home Innovation Research Labs, Inc.
400 Prince George's Boulevard
Upper Marlboro, MD 20774

Report # 3323.001_11132013

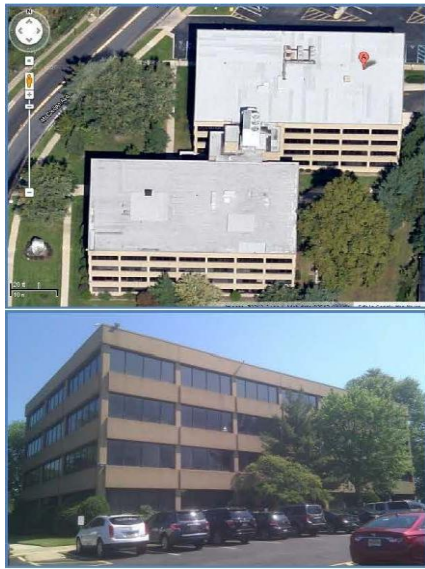
Figure 1. Office Building Upgraded with Low-E Window Retrofit Panels

Addressing these concerns for envelope upgrades, an innovative retrofit window technology has been installed to decrease the window U-factor and add a low emissivity (low-E) coating. The window retrofit was performed on The Kevon Center located on McClellan Ave in Pennsauken, NJ. The project structure is a four-story office building built in 1970, and comprises 100,000-square-feet of offices. It features 651 windows that cover 19,000 square feet. Prior to this retrofit, the only window alteration which had been performed was the addition of a window film on the interior surface. The window retrofits are performed such that occupants are not required to vacate office space and no existing materials other than the existing window film requires disposal.

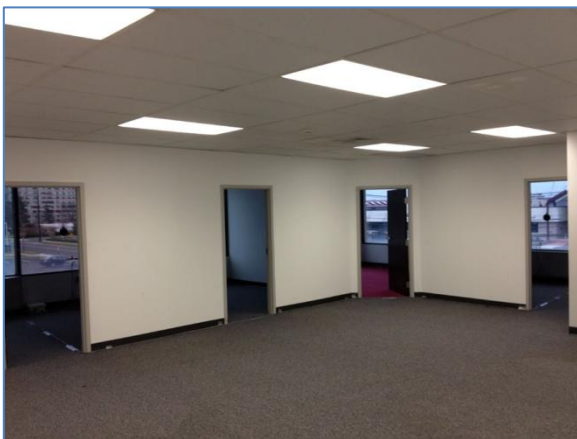
Figure 2. West and South Facing Test Offices (indicated by floor cables)

In order to understand the characteristics of the installed low-E window retrofit panel upgrade, two offices were instrumented with temperature sensors located in various locations in the room – on the windows surfaces and in the space between the existing and retrofit window panels. One office exposure was to the west and one was to the south (Figure 2). Each office had two sets of identical windows.

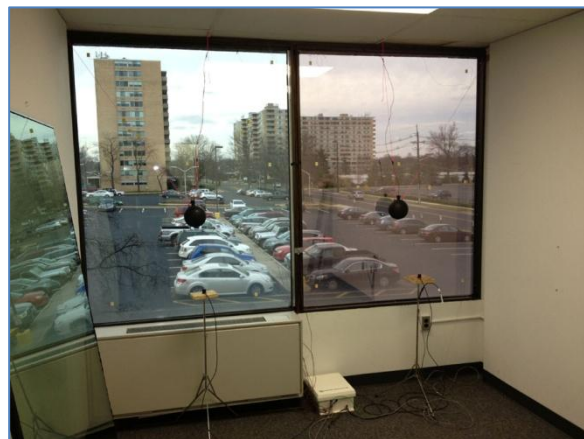
Figure 3. Test Office with One Low-E Retrofit Panel Installed (left side)

For each test office, one window was kept with the original single-pane window with an interior film and the adjacent window was retrofitted with the low-E retrofit panel (Figure 3)¹. Prior to the installation of the low-E retrofit panel, the existing window film was removed to provide a clean surface on the existing window.

¹ To the left in Figure 3 is the Retrofit Panel to be installed at the test conclusion.

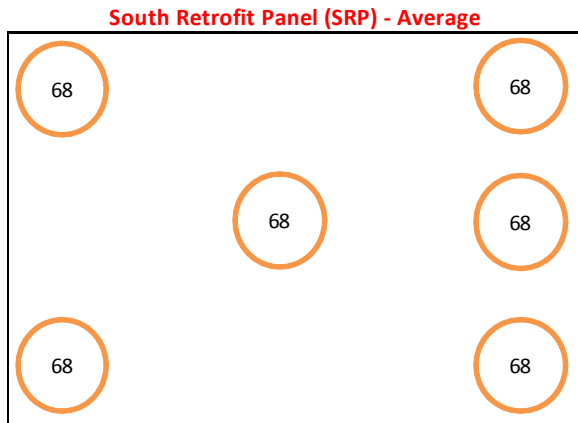
Figure 18. Average South Window Surface Temperature, °F

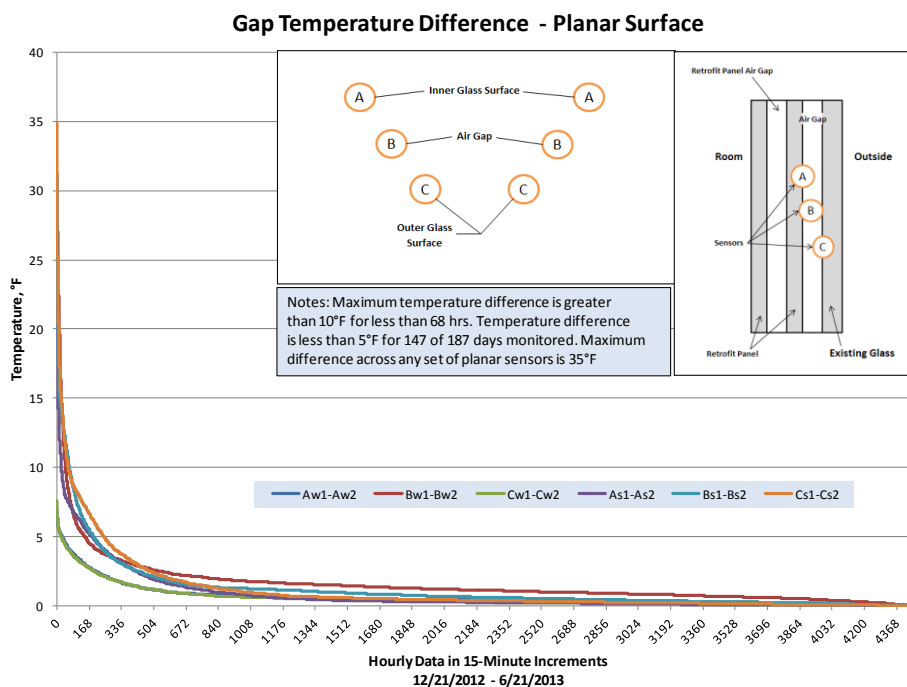
Figure 26 shows the temperature difference across the plane of the glass layers and the air gap for any 15-minute period. The data is sorted to show the largest difference and the duration (in hours, x-axis).

Figure 26. Planar Sensor Temperature Difference in Gap of Retrofit Panel Window

The maximum temperature difference (typically on the inside surface of the original pane, Cs1-Cs2) was only more than 10°F (500 psi) for 68 hours out of 187 days monitored, or 1.5 percent of the time. In all cases, the maximum temperature difference was no more than 35°F, or 1,750 psi. The placement of the temperature sensors may have missed some effects in the corners where the temperature difference may be more than measured here, but overall, there does not appear to be any significant concern with thermal stress when using the low-E retrofit panel. Furthermore, when comparing to similar sensor positions on the original single pane with the solar control film, there are no significant differences in the maximum surface temperature differences, and no reason to expect any difference in the potential for thermal stress breakage.

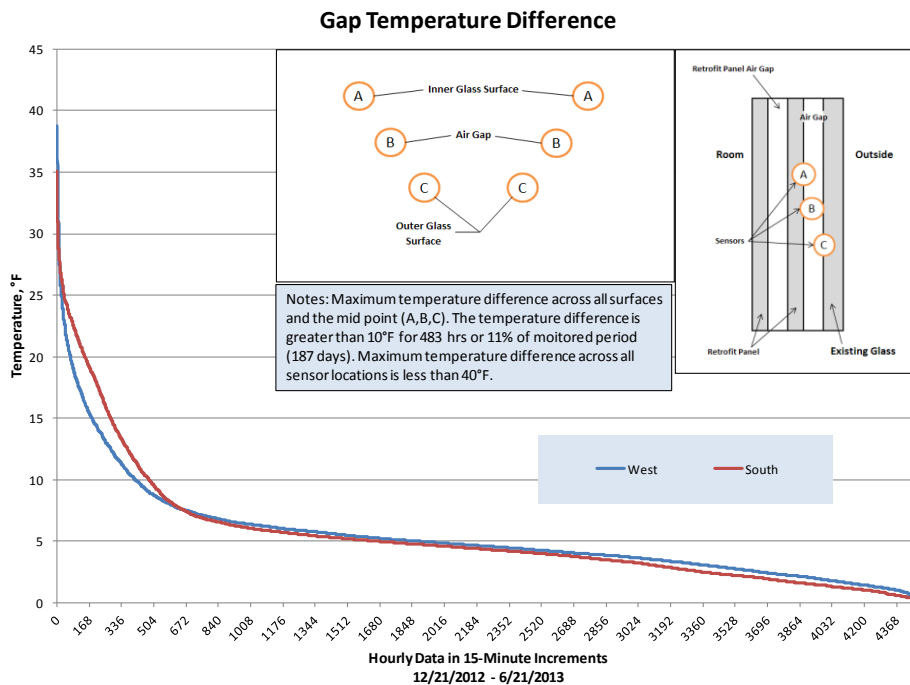
In addition to the planar temperature difference for each set of sensors, the maximum temperature difference across all positions on both sides and within the gap (sensor locations A, B, and C) for all 15-minute periods, sorted by magnitude, is shown in Figure 27.

Figure 27. Maximum Temperature Difference between Gap Sensors of the Retrofit Panel Window

In all cases, there is no more than 35°F temperature difference within the gap space between the existing window and the retrofit panel during the monitoring period.
